TCEQ Interoffice Memorandum

Subject: TX00037 – Lake Mark Dam
Polk County, Texas

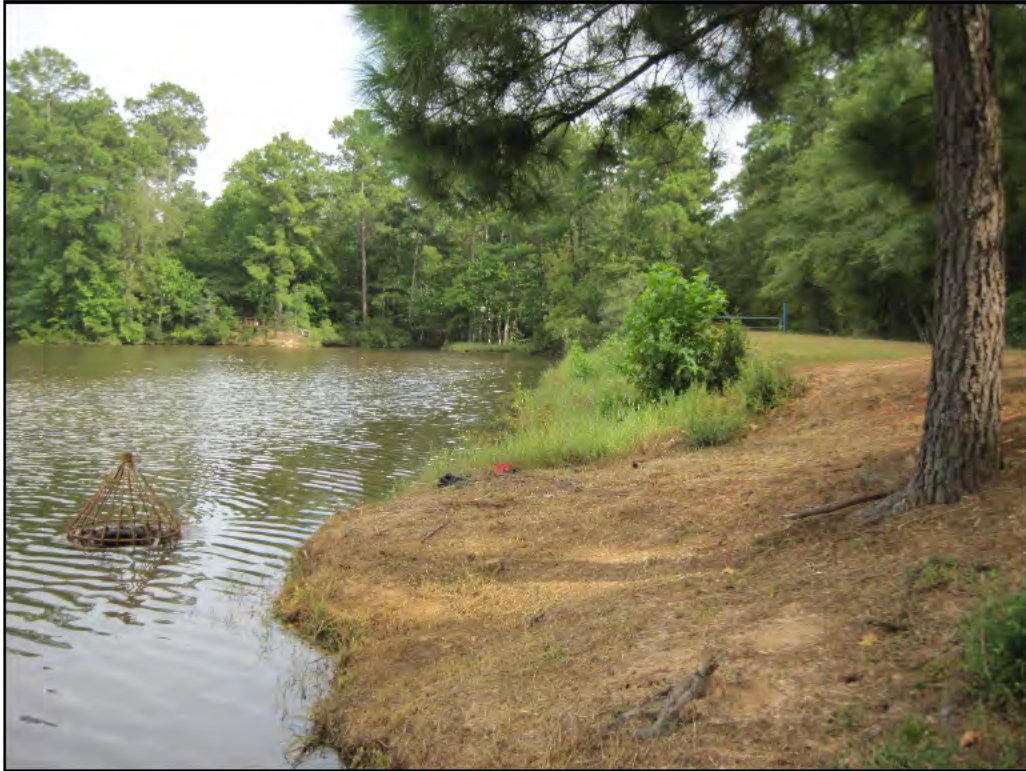
- The drop-inlet spillway was engaged 1 inch over the spillway lip at the time of the inspection. (Photo 1)
- The sinkhole was observed on the downstream edge of the crest in line with the drop-inlet spillway. The sinkhole was approximately 11 feet in diameter and 5 feet

Photo 1: The drop-inlet spillway was engaged 1 inch over the spillway lip at the time of the inspection.

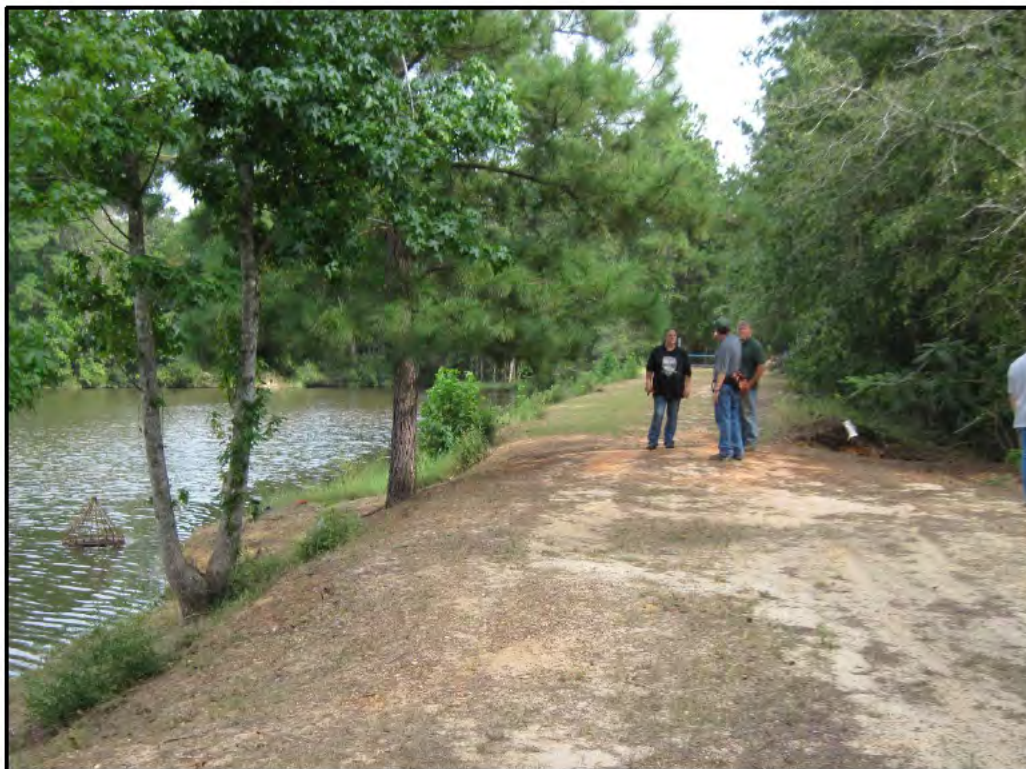
deep (Photos 2-4). The location of the sinkhole above the barrel pipe of the spillway suggests a failure in or around the pipe during the high flow conditions.

Photo 2: The sinkhole was observed on the crest in line with the drop-inlet spillway.

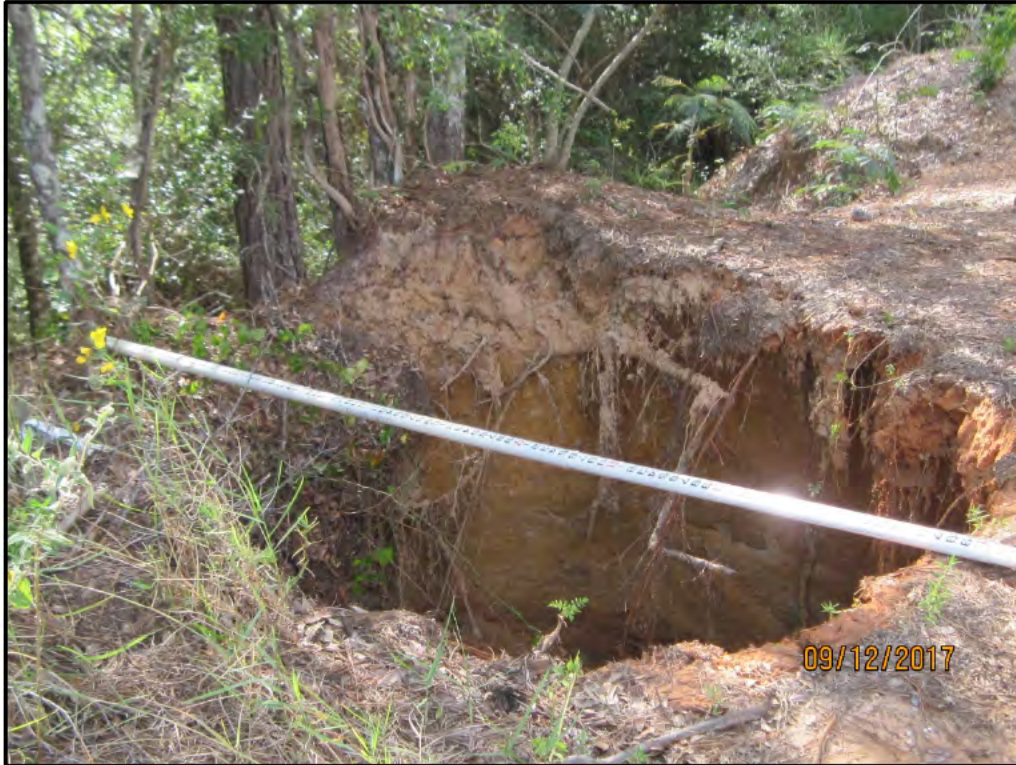
Photo 3: The sinkhole was approximately 11 feet in diameter.

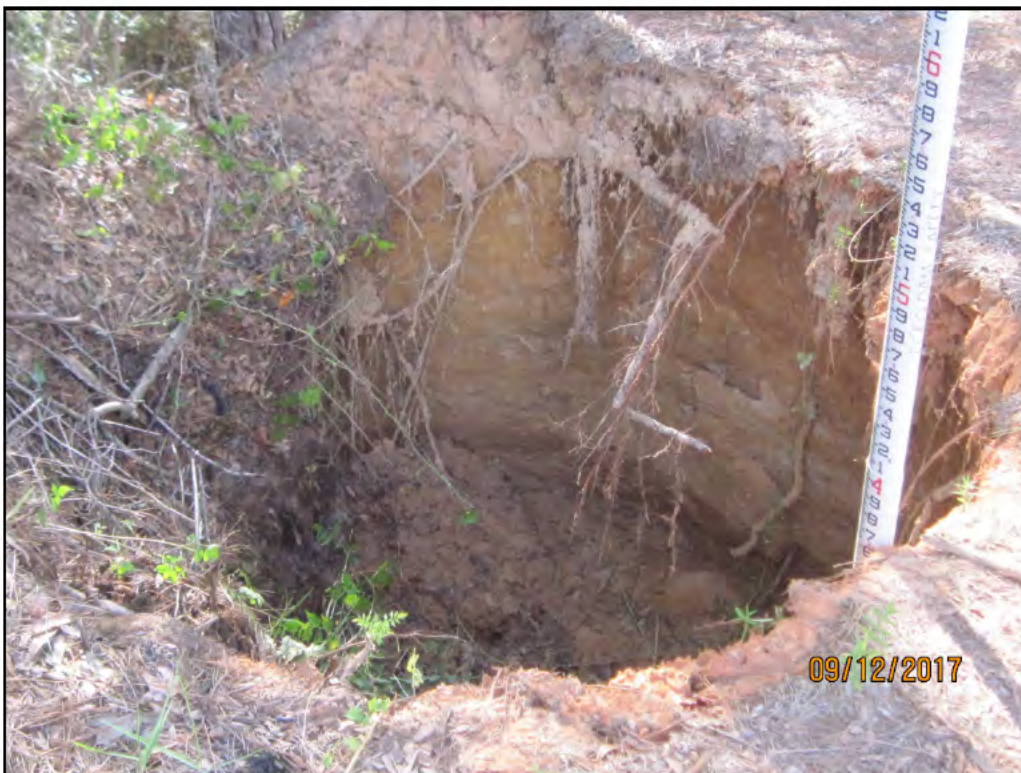
Photo 4: The sinkhole was approximately 5 feet deep.

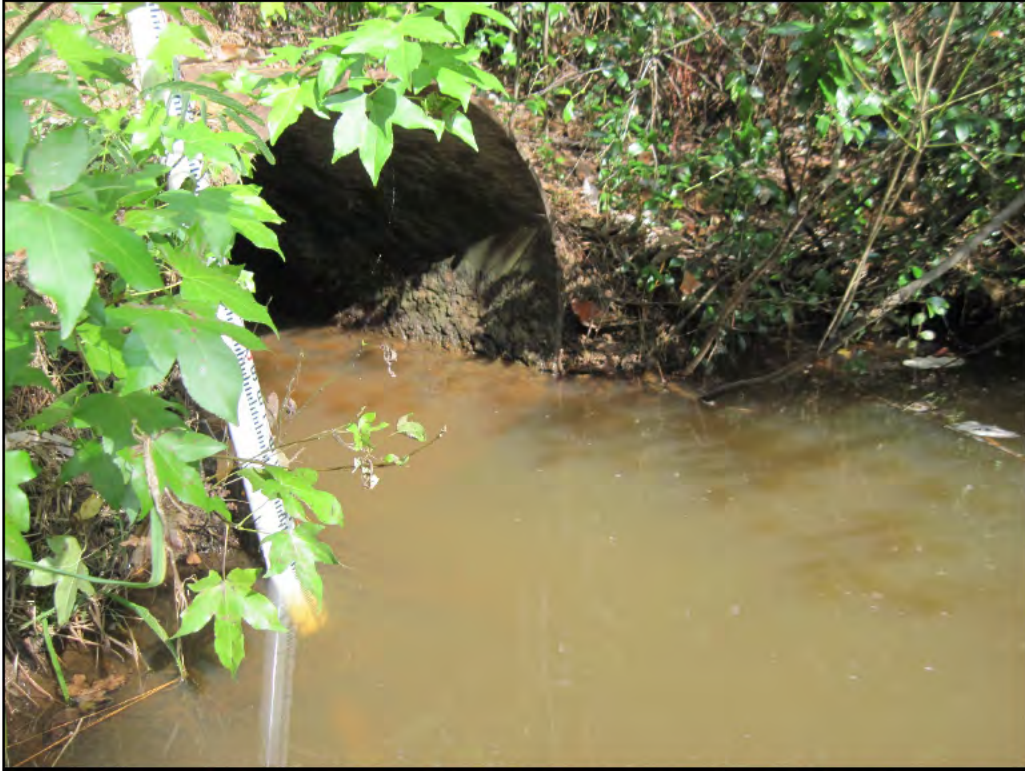
- No damages were observed at the outfall of the 3 feet diameter spillway outlet pipe (Photo 5-6).
- A depression of approximately 3 feet deep was observed on the crest near the right end of the dam (Photo 7). The owners discussed the option of improving this depression to serve as a spillway if they choose to cap the drop inlet spillway.

Photo 5: Spillway outlet pipe was a 3 feet diameter smooth metal pipe.

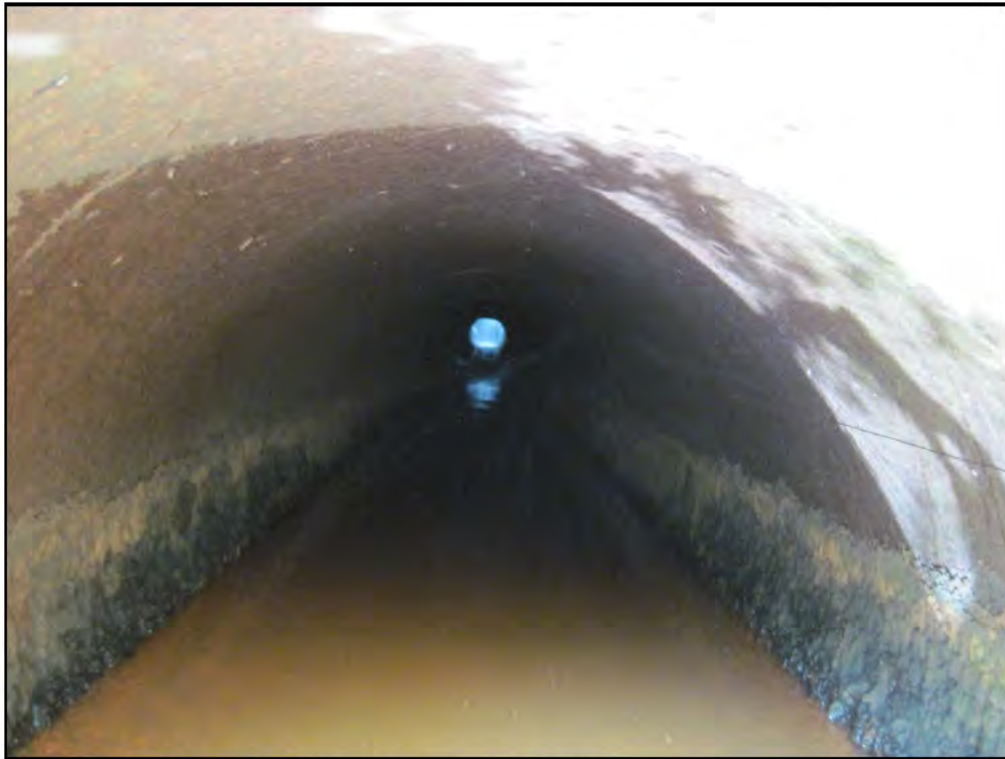
Photo 6: View looking up the spillway outlet pipe.

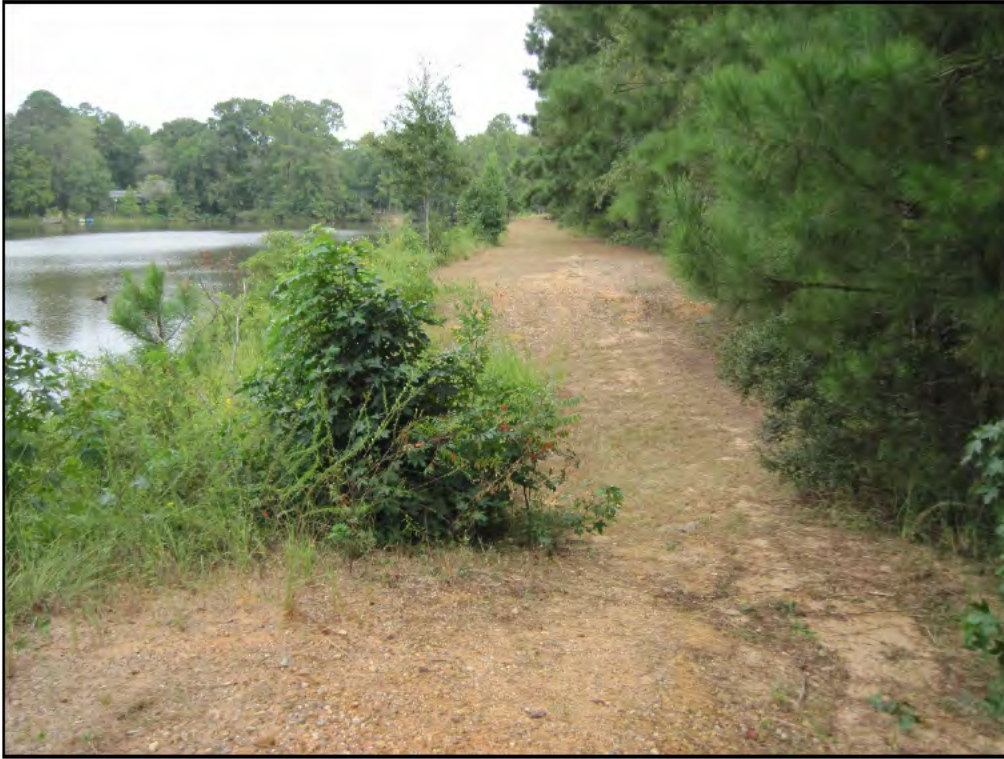
Photo 7: Depression on the right end of the dam.
